Hotmarker SP series

Caution when using “white line-out” reduction mode

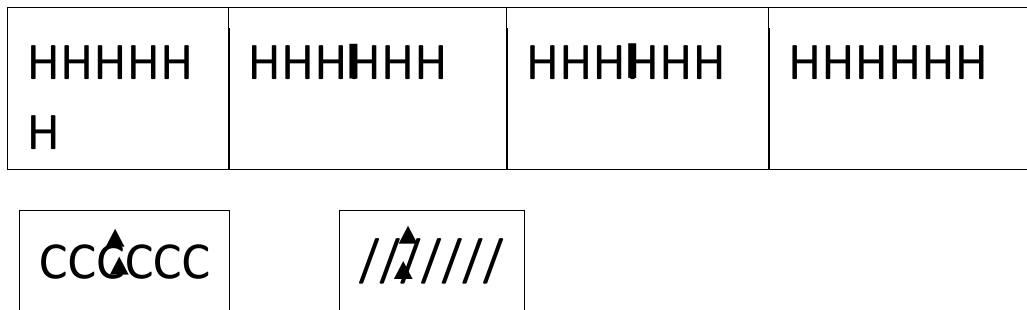
While recent Hotmarker models comes with a function to reduce occurrence of "white line-out." However, if the “white line-out”* reduction mode is turned on, the **line width may become thicker** (as shown below) when thermal head stops at the edge of a character.

Please adjust the value in the “Table” so that the position of thermal head is located between (not at the edge of) the characters when the printer pauses for cutting.

1. Set the horizontal pitch between characters (“Phor”) larger than the current value
(This is not applicable to integrated data with a Windows TrueType font.)
2. Change cutting position (“C.POS”)
3. Add 0.3 to 0.6 to the current value for “F.ADJ” (feeding rate adjustment).

If the same problem continues to occur after the above measures have been taken, or if this problem occurs first time, we recommend inspection drive rollers, as slippage in the conveyor section may be the cause. Followings are three possible solutions:

1. Checking the drive rollers to make sure to see if it is installed properly
2. Cleaning drive rollers
3. Replacement of drive rollers
