Hotmarker SP Series

Cutter arm error Recovery method

If the cutter cam is engaged and becomes inoperable, follow the steps below.

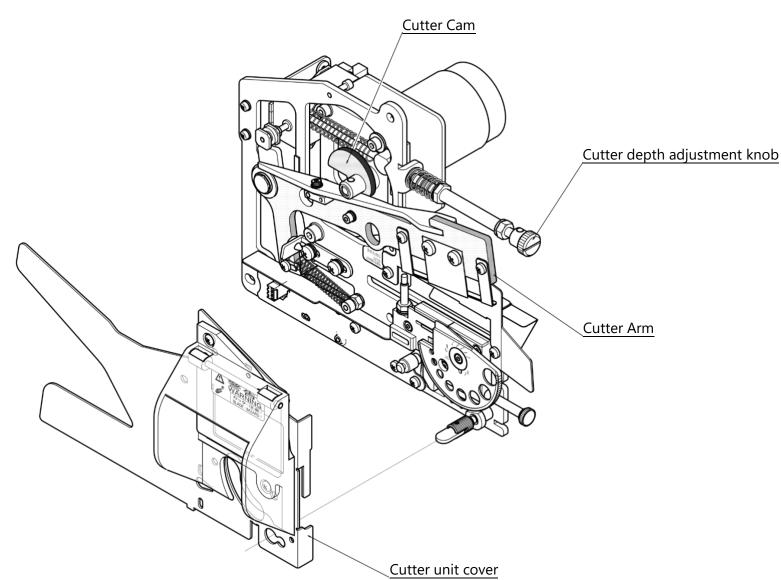
- Be sure to turn the "main power switch" to "OFF" and unplug the "power cord" from the outlet. Failure to do so may result in injury from malfunction.
- The tip of the cutter blade is very sharp. Please be careful not to cut your fingers.
- 1. Turn the cutter depth adjustment knob about 5 turns to the left (to make the depth shallower).
- 2. Remove the main cover of the Hotmarker body by removing the two M3 binding screws on the top and rotating the cover backward. (Refer to Instruction Manual II)
- 3. Remove the cutter unit cover.

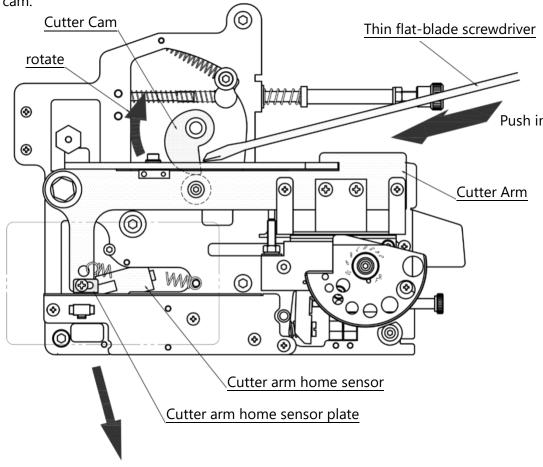
4. Push in the lower part of the cutter cam with a thin flat-blade screwdriver and rotate the cam.

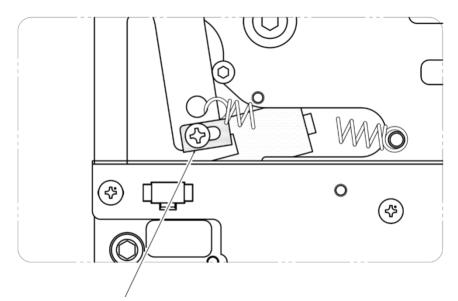
5. Make sure that the cutter arm is lifted and the cutter arm home sensor responds normally.

Make sure that the sensor plate goes through the sensor properly (If the sensor plate is detected, the pilot lamp is turned on.)
